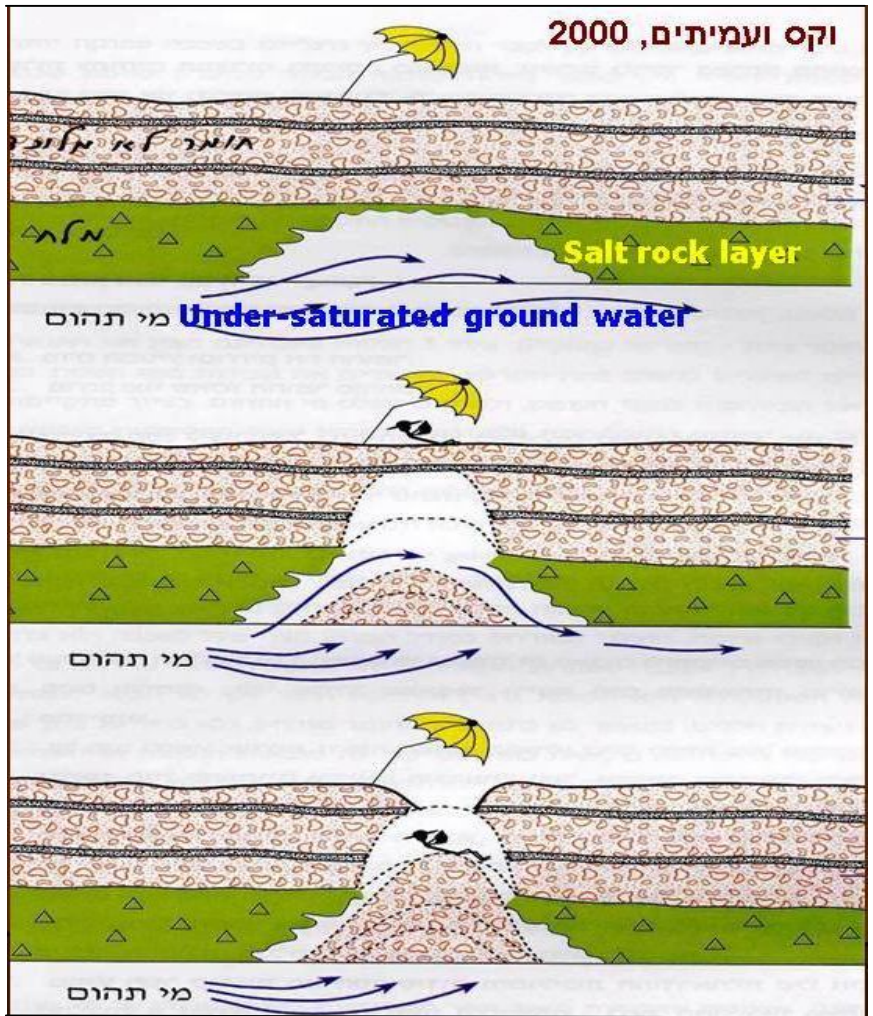
Hypothetic salt rock layer undergoing dissolution by under saturated ground water

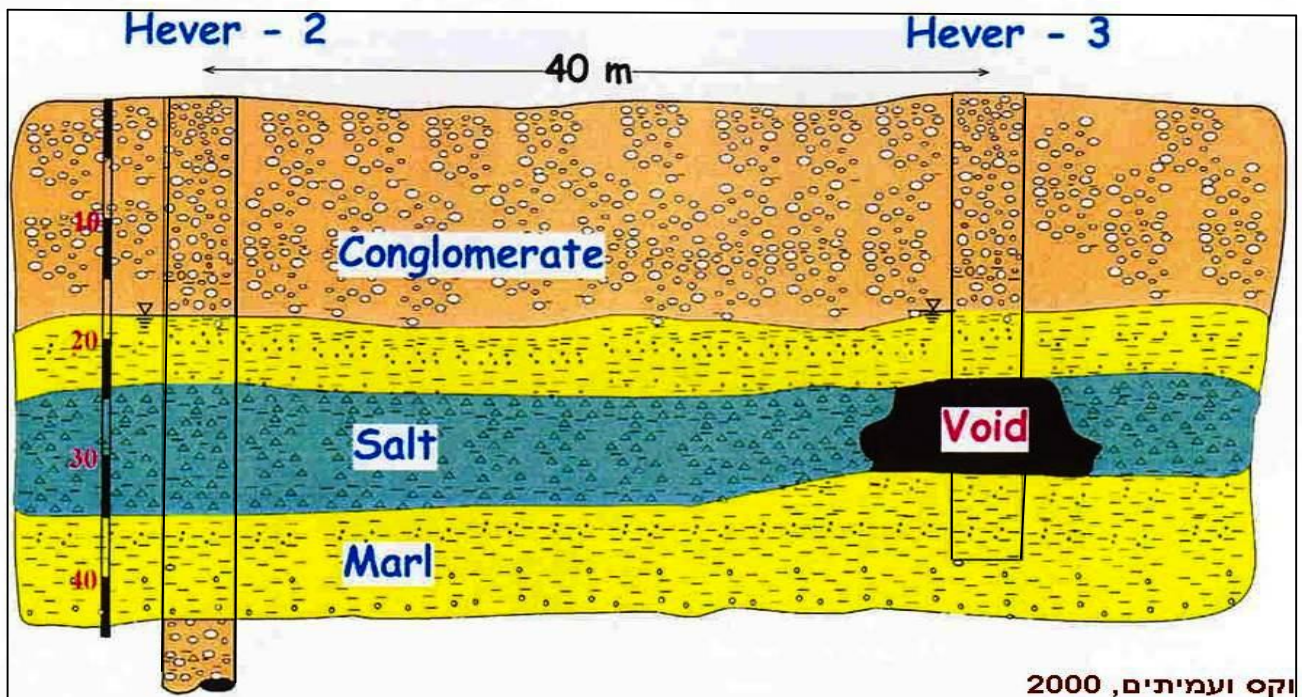
Confirmation of the existence of a salt rock layer containing huge voids, by drillings

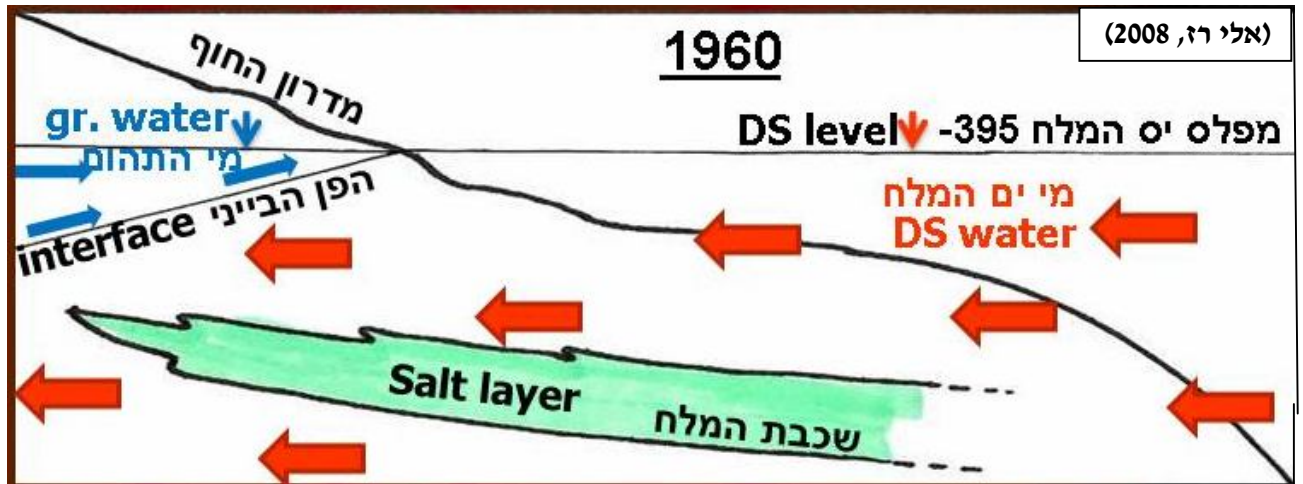
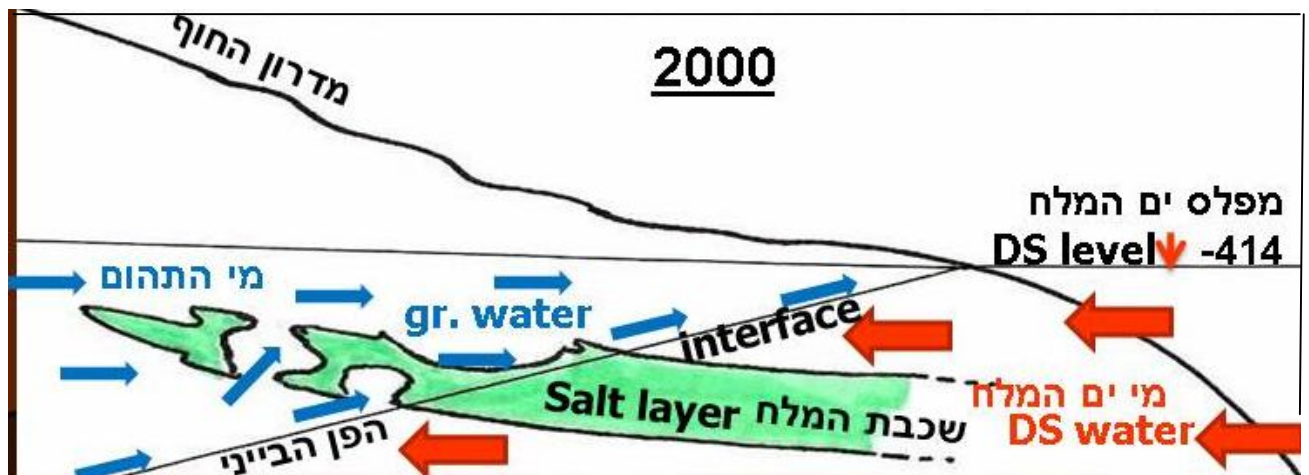
Exposure of the salt rock layer to dissolution by ground water following the sink of the interface, as a consequence of the drop in the level of the Dead Sea
